# Filler Metal Management in NOCOLOK® Flux Brazing of Aluminium

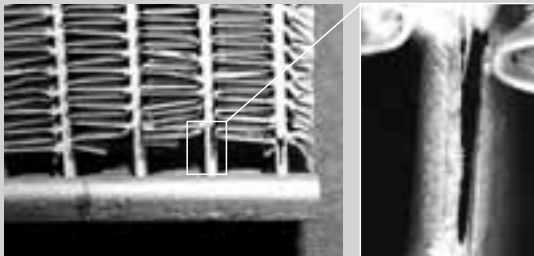
- The fluidity of the filler metal at the tube to header joint is increased and some of the liquid filler metal is released and flows to the nearest tube to fin joints.
- Excess filler metal now at the tube to fin joints accelerates dissolution of the tube core adjacent of the fin, eroding the tube wall thickness.
- The excess filler metal pool is then drawn by capillary action in between the fins, particularly where the fin spacing is narrow. The fins are drawn together by the strong capillary forces, displacing the fin from its original fin to tube position.
- As the fins move together, drawing the filler metal pool from its original position, the denuded area is significantly reduced in cross sectional thickness.

In some instances the extent of filler metal erosion is so severe that the entire thickness of the tube is consumed resulting in catastrophic failures.

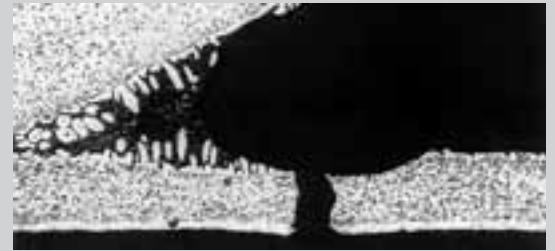
A radiator core retrieved from service was examined for a suspected premature corrosion related failure. Upon closer metallographic examination, no evidence of corrosion was found at the failed area.

33% tube core erosion in the failure area

It was concluded that the cause of the failure was in fact a mechanical failure occurring in the thinned wall area.

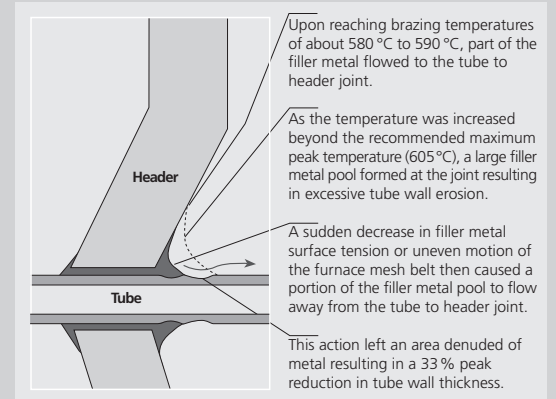
The following sequence of events proposes a rational explanation for the eroded tube area:

In service radiators are subject to internal pressure fluctuations and expansion and contraction due to heating and cooling. Mechanical failure was imminent and

occurred in the weakest part of the tube, the thinned down tube wall area adjacent to the tube to header joint.
