# Perspectives of Aluminum as a Construction Material for Stationary Air-Conditioning Systems

Product Bulletin no. C/06.00/14/E

F. Flohr, C. Meurer, Dr. H.-W. Swidersky, Dr. H.-J. Belt Solvay Fluor und Derivate GmbH, Hannover, Germany

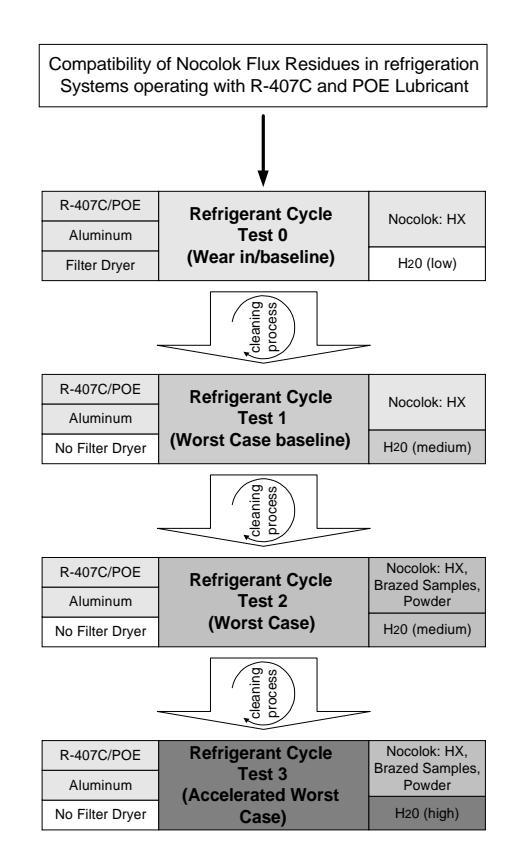
Figure 1: Research Program: Compatibility of Nocolok<sup>®</sup> Flux in refrigerating systems operating on R 407C and POE lubricant.

The test program that is described in figure 1 was carried out to obtain knowledge on interactions of Nocolok<sup>®</sup> Flux residues in refrigeration and air conditioning systems operating with R 407C and POE lubricant.

The program consists of four tests in which the operating conditions have gradually been debased, up to the point in which a much higher amount of moisture than normally accepted was in the system. Each test took about 500 h, except test 0, which was performed to generate a base line and to exclude any malfunctions of the test rig.

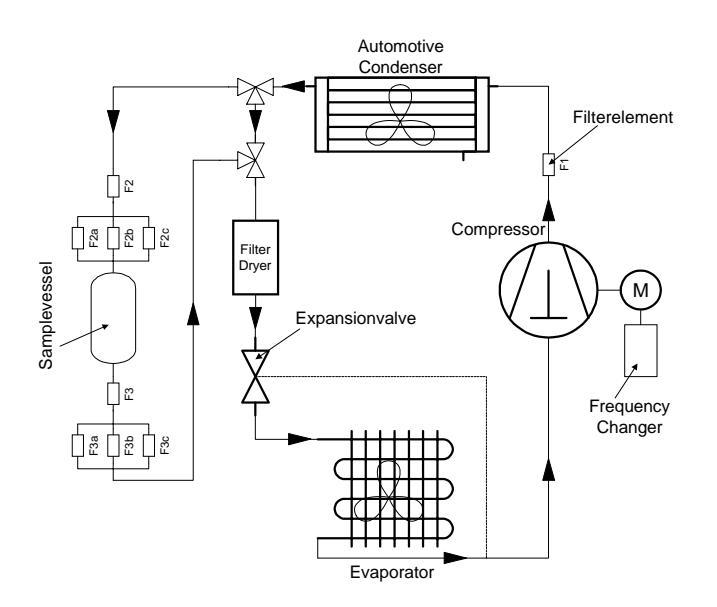
### Figure 2: Schematic diagram of the test apparatus

The test rig that was used for the stability tests was already described in [1]. For easier understanding, a schematic diagram is given in figure 2.

For building the test apparatus, only selected materials were utilised. Apart from sealing material (mostly PTFE and paper sealing of the compressor) the complete test rig is made of stainless steel and aluminium for the evaporator and the condenser. It was essential to choose those components to minimise the amount of influencing parameters in order to be able to detect possible sources of problems.

A test section consisting of filter elements and a sample vessel was located in the liquid line. The filter elements are made of wire mesh-and dry powdered-stainless steel and are used as an indicator of chemical reactions or corrosion effects. Before and after the sample vessel a combination of a 40 micron filter followed by three 15 micron filters in parallel and in direction of the flow was implemented. Before each test, a new set of filter elements was fitted into the test section to ensure equal conditions for each test. A frequency converter was added to the setup in order to adapt the rotational speed of the compressor to the volumetric capacity of R407C.

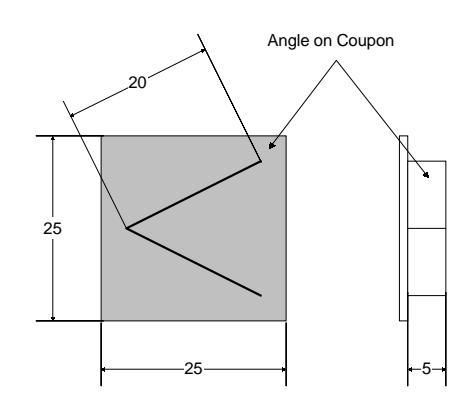
### Figure 3: Angle on Coupon Samples

For test 2 and 3, the surface of 45 aluminium coupons (see Figure 3) were coated with Nocolok<sup>®</sup> Flux. To simulate joints as produced by continuos furnace processes, aluminium angels were brazed under nitrogen to these coupons.

Coupon:	Sizes 25 x 25 x 0.4 mm
Basic Material:	AA 3003
Brazing Material:	10 % AA 4343 (7.5 % Si)
Thickness:	0.4 mm
Angle:	Sizes 40 x 5 x 0.5 mm, Angle $45^{\circ\circ}$ , Material 99.5 Al
Coating:	5 g / m <sup>2</sup>
Brazing:	30°°C / min. until 600°°C, for 2 min.

40 of the 45 coupons were introduced in the sample vessel on different levels. The remaining five coupons were used as a reference after the tests. The preparation of the angles on coupon are described in detail in [2].

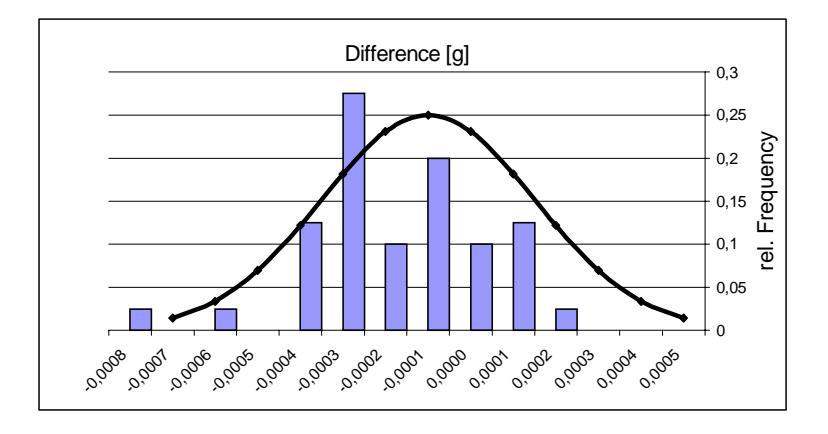
#### Frequency distribution Test 3 Figure 4:

total	total after	difference
	before	test [g]:	[g]:
	test [g]:		
Test 2:	38,360866	38,3596	-0,0012666
Test 3:	38,252366	38,244466	-0,0079

The measured weight differences of the coupons are close to the precision tolerance of the scale ( $\pm$  0,0001g). Weight deviations between test 2 and virgin conditions are within the inaccuracy of the scale and therefore insignificant.

A slight weight loss between virgin conditions and test 3 was detected which could have been caused by abrasion effects.

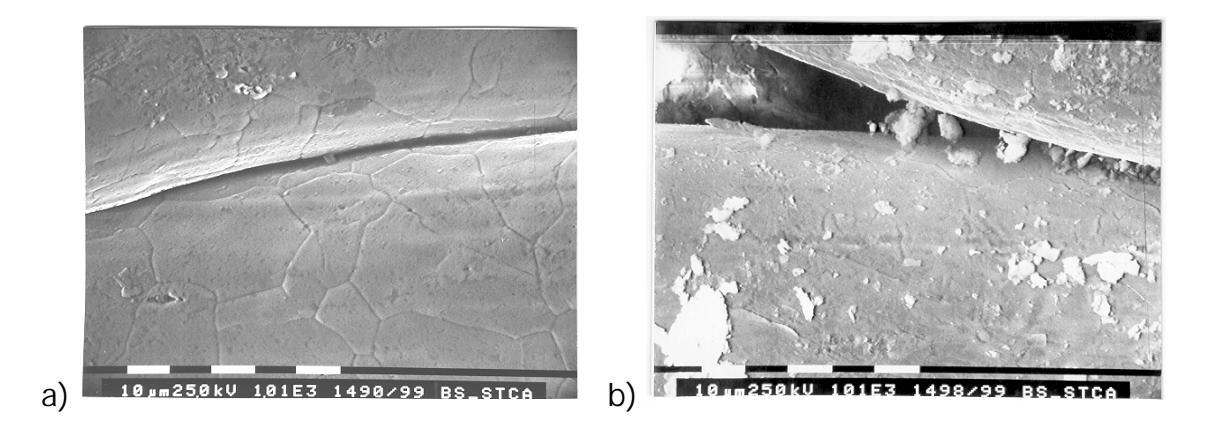
Figure 5: 1000-fold increase shot of a stainless-wire-mesh filter element:

- a) before test 3
- b) after test 3

Optical analysis were made on the surfaces of the tube elements, the compressor's valve plate, the coupons and the filter elements. The results were documented with photos. Neither on the surface of the coupons nor on the tubes' surfaces or on the compressor's valve plate any kind of corrosion effects were visible. Figure 5 shows the condition of a stainless wire mesh filter element before and after test 3. The residues which are visible after test 3 consist of loose Nocolok<sup>®</sup> Flux powder which was incorporated into the sample vessel prior to the test.

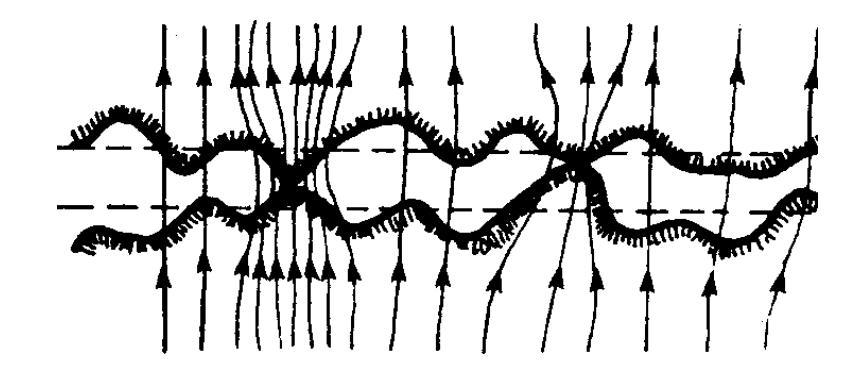
Figure 6: Heat transfer through two surfaces in contact

Mechanically expanded finned tube heat exchangers are the most prominent choice for the air-side heat exchange of stationary refrigeration and air-conditioning systems. Copper and aluminium for the tube and fin respectively are the materials of choice. The fins have bear collars which serve to fix the fin on the tube through mechanical or hydraulical expansion of the tube. Two surfaces in contact create an imperfect interface that impedes heat transfer between the two surfaces (figure 6). The impedance is known as the contact resistance.

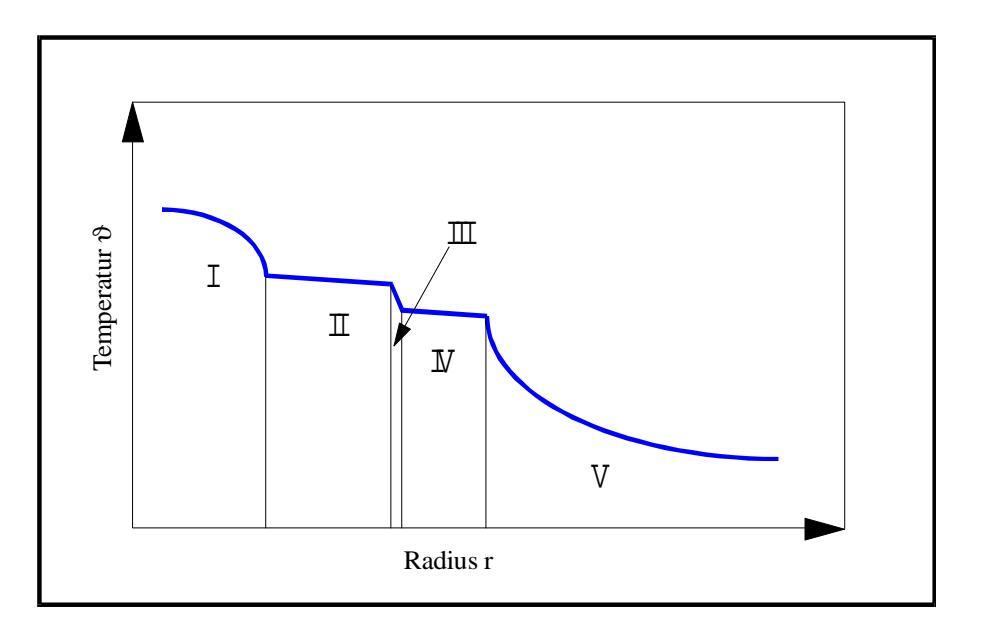
#### Figure 7: Temperature curve through a finned tube profile

A simplified description of the heat transfer through a finned tube heat exchanger is shown in figure 7. Five sectors can be assigned to the temperature curve. Sector I describes the heat transfer from the fluid 1 to the inner tube surface, sector II the heat conductance through the tube wall, sector III the heat transfer between outer tube wall and fin collar, sector IV the heat conductance through the fin and sector V the heat transfer from the fin surface to the air.

Section III that describes the contact resistance between tube wall and collar can take up to 12% of total heat resistance. [3].

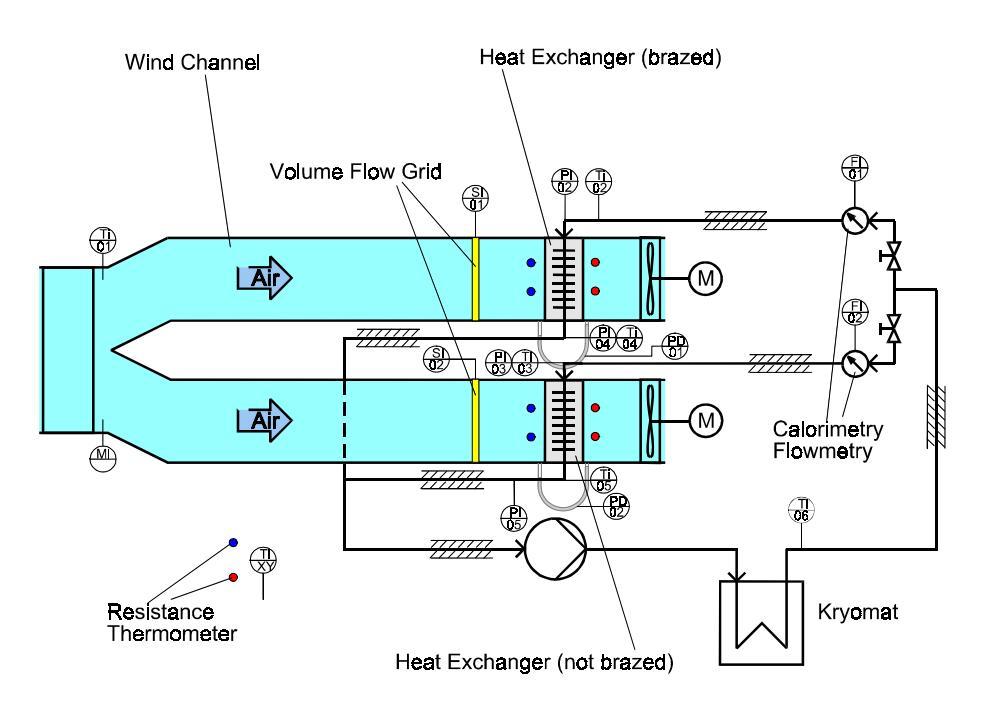
### Figure 8: Test rig for the direct comparison of different heat exchangers

For the practical evaluation of the heat transfer benefit, SOLVAY will perform a series of tests. Therefore a test rig was built which allows to compare heat exchangers of different designs under same conditions (figure 8). First results are expected in the second half of the year 2000.
